# Convention Conversion

**Project: Minneapolis Convention Center Expansion**  
**Second Ave. So. and Grant St., Minneapolis, Minn.**  
**Cost: \$210 million**

# CONCRETE REPAIR FAILURE:

## DISCOVERING WHAT WENT WRONG

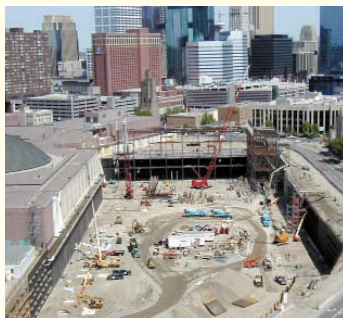
*Photo below: A fifty-foot-deep excavation was required to provide new below- and above-grade exhibit halls capped by a fourth copper dome.*

Creating a deep excavation immediately adjacent to the existing slab-on-grade exhibit hall presented a design/engineering and construction challenge to the design/construction team. AET was fortunate to be chosen by the City as their geotechnical, materials, and special inspection consultant for the complex project. With competent bedrock at a depth of 55' to 65' below grade, no near surface groundwater conditions, and the construction of a special perimeter tie-back retention wall system, the majority of the property limits were excavated to an elevation just slightly above bedrock.

**Two innovative construction approaches** were used to create this significantly-sized, deep perimeter foundation wall. The deep walls rely on a permanent tie-back retention system which incorporates several levels of special corrosion-protected soil anchors that restrain the lateral forces imposed by the earth, structures and streets next to the building expansion. Also, walls were slip-formed in 140 long sections with a special concrete mix to improve the efficiency of foundation wall placement. According to Rodney Leibold, project coordinator for the City, "integrating the new building with the old, controlling project costs and meeting the high standards of quality for the modern facility were our top priorities."

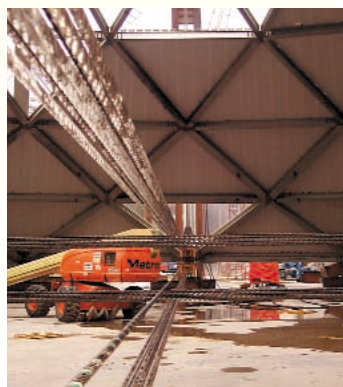
*Photo bottom: Construction, raising, and securing the dome roof proved a technological sight to behold.*

The completed space frame for the dome now defines the center's outline. When completed, it will offer facilities and meeting space unparalleled in quality and layout for the growing convention market. The staff of AET is proud of involvement in both the original construction and enhancement of this exceptional facility. **A**

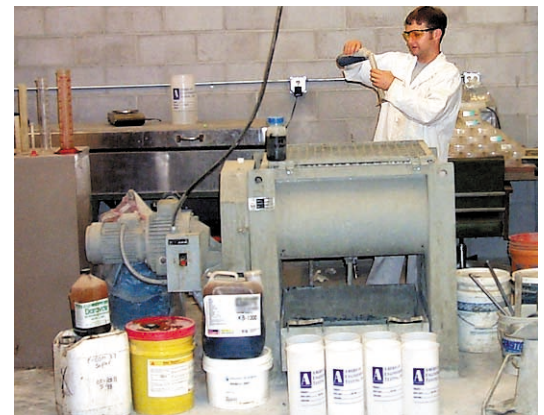
*Concrete Specialist Tim Suess measures chemical admixture for trial batching.*
